# **EVALUATION OF AN ADVANCED NON-REGENERATIVELY COOLED ROCKET THRUST CHAMBER CONCEPT**

**THE MARQUARDT CORPORATION**

**TECHNICAL REPORT AFRPL-TR-67-89**

**JANUARY 1967**

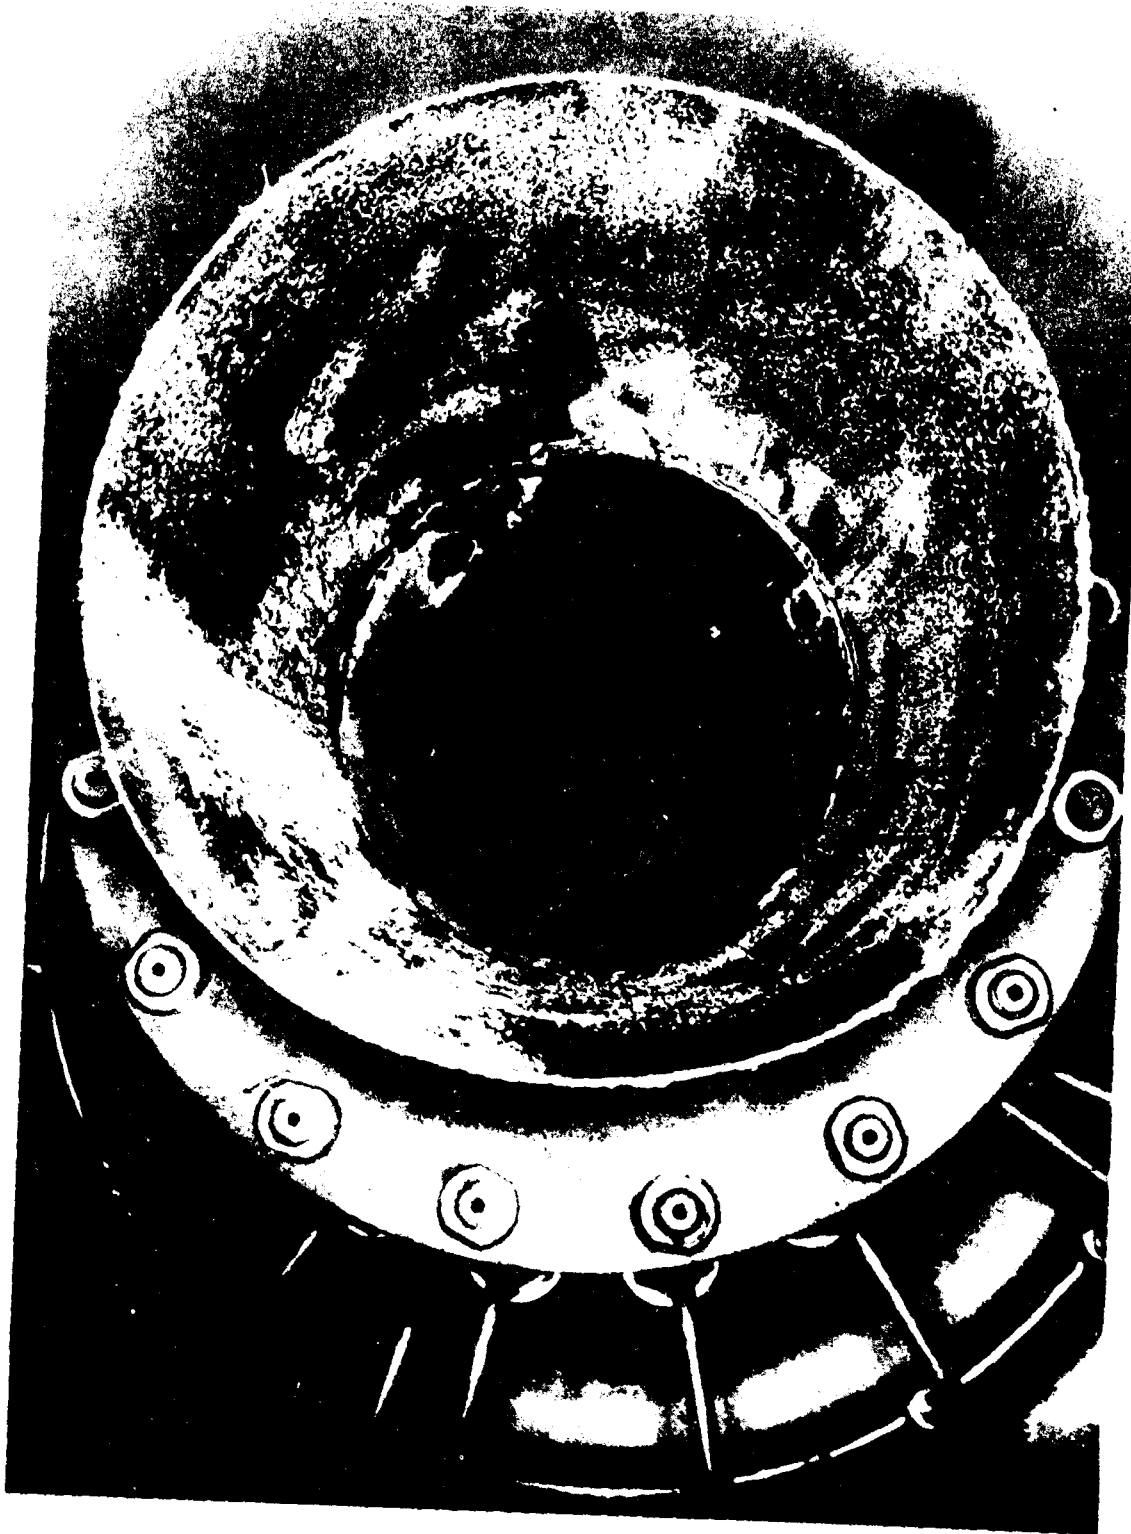
Figure 23  
EXIT CONE DAMAGE - ASSEMBLY NO. 1 AFTER 5 SECOND TEST AT AFRPL

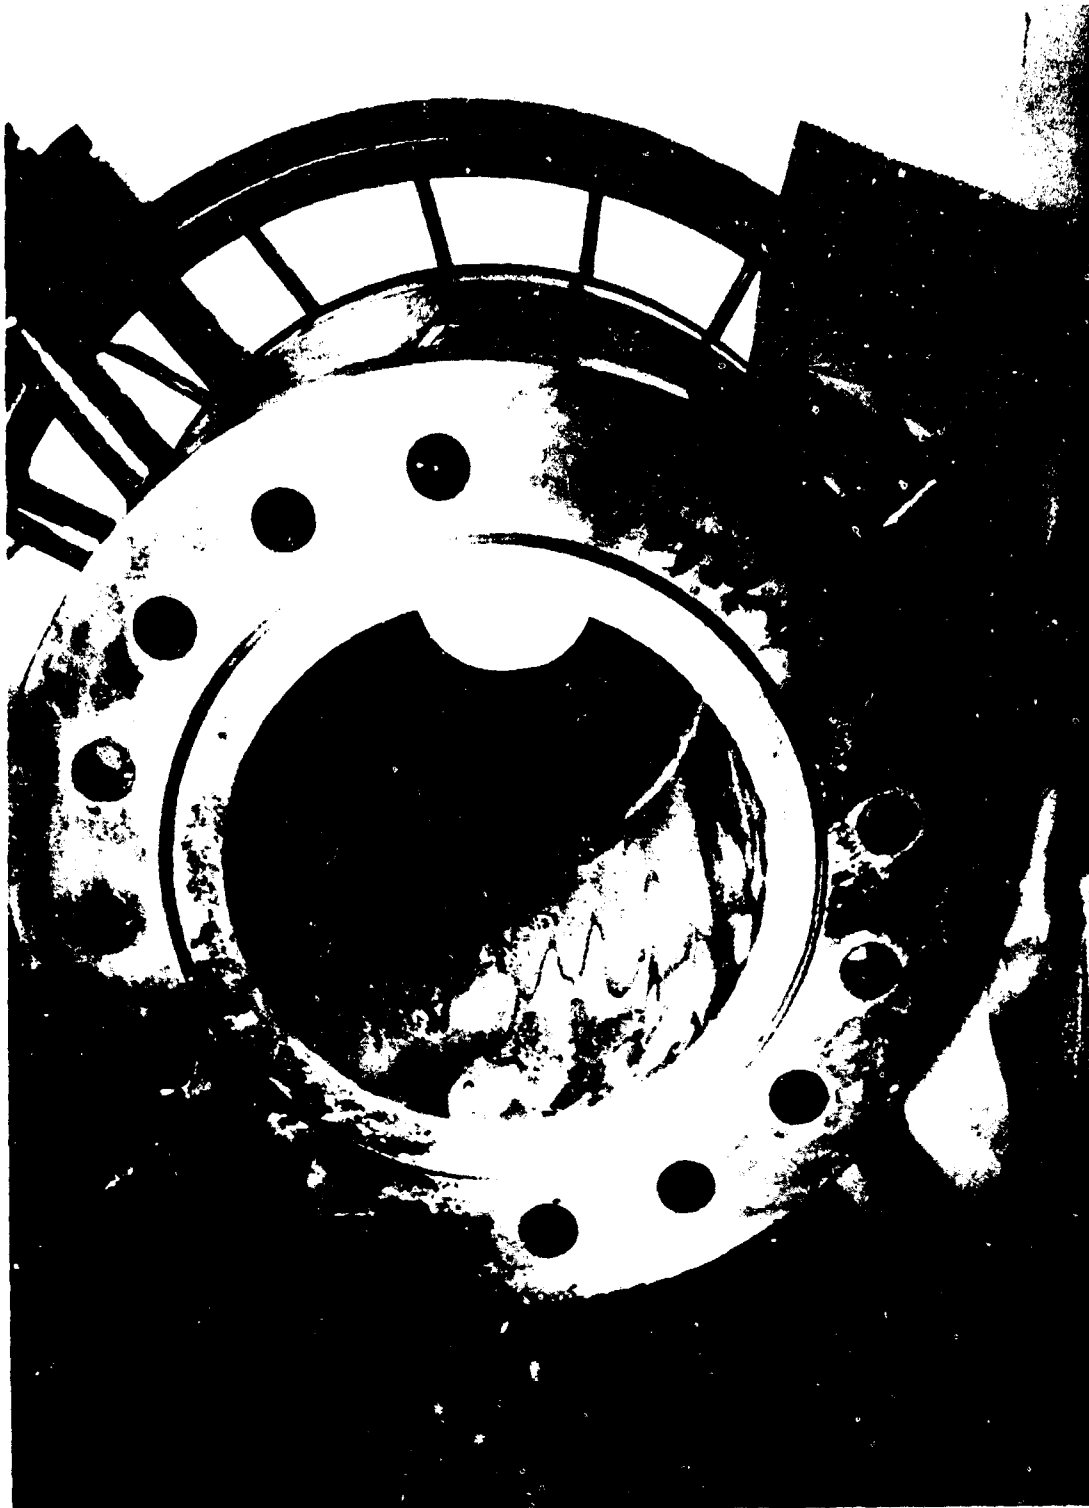
Figure 26

CHAMBER AREA - ASSEMBLY NO. 1 AFTER 5 SECOND TEST AT AFRPL
